BROWNFIELD REDEVELOPMENT ASSESSMENT REPORT

CARTER COLOR COAT
(formerly GMC Fisher Body Plant 21)

DETROIT, MICHIGAN

April 30, 1997

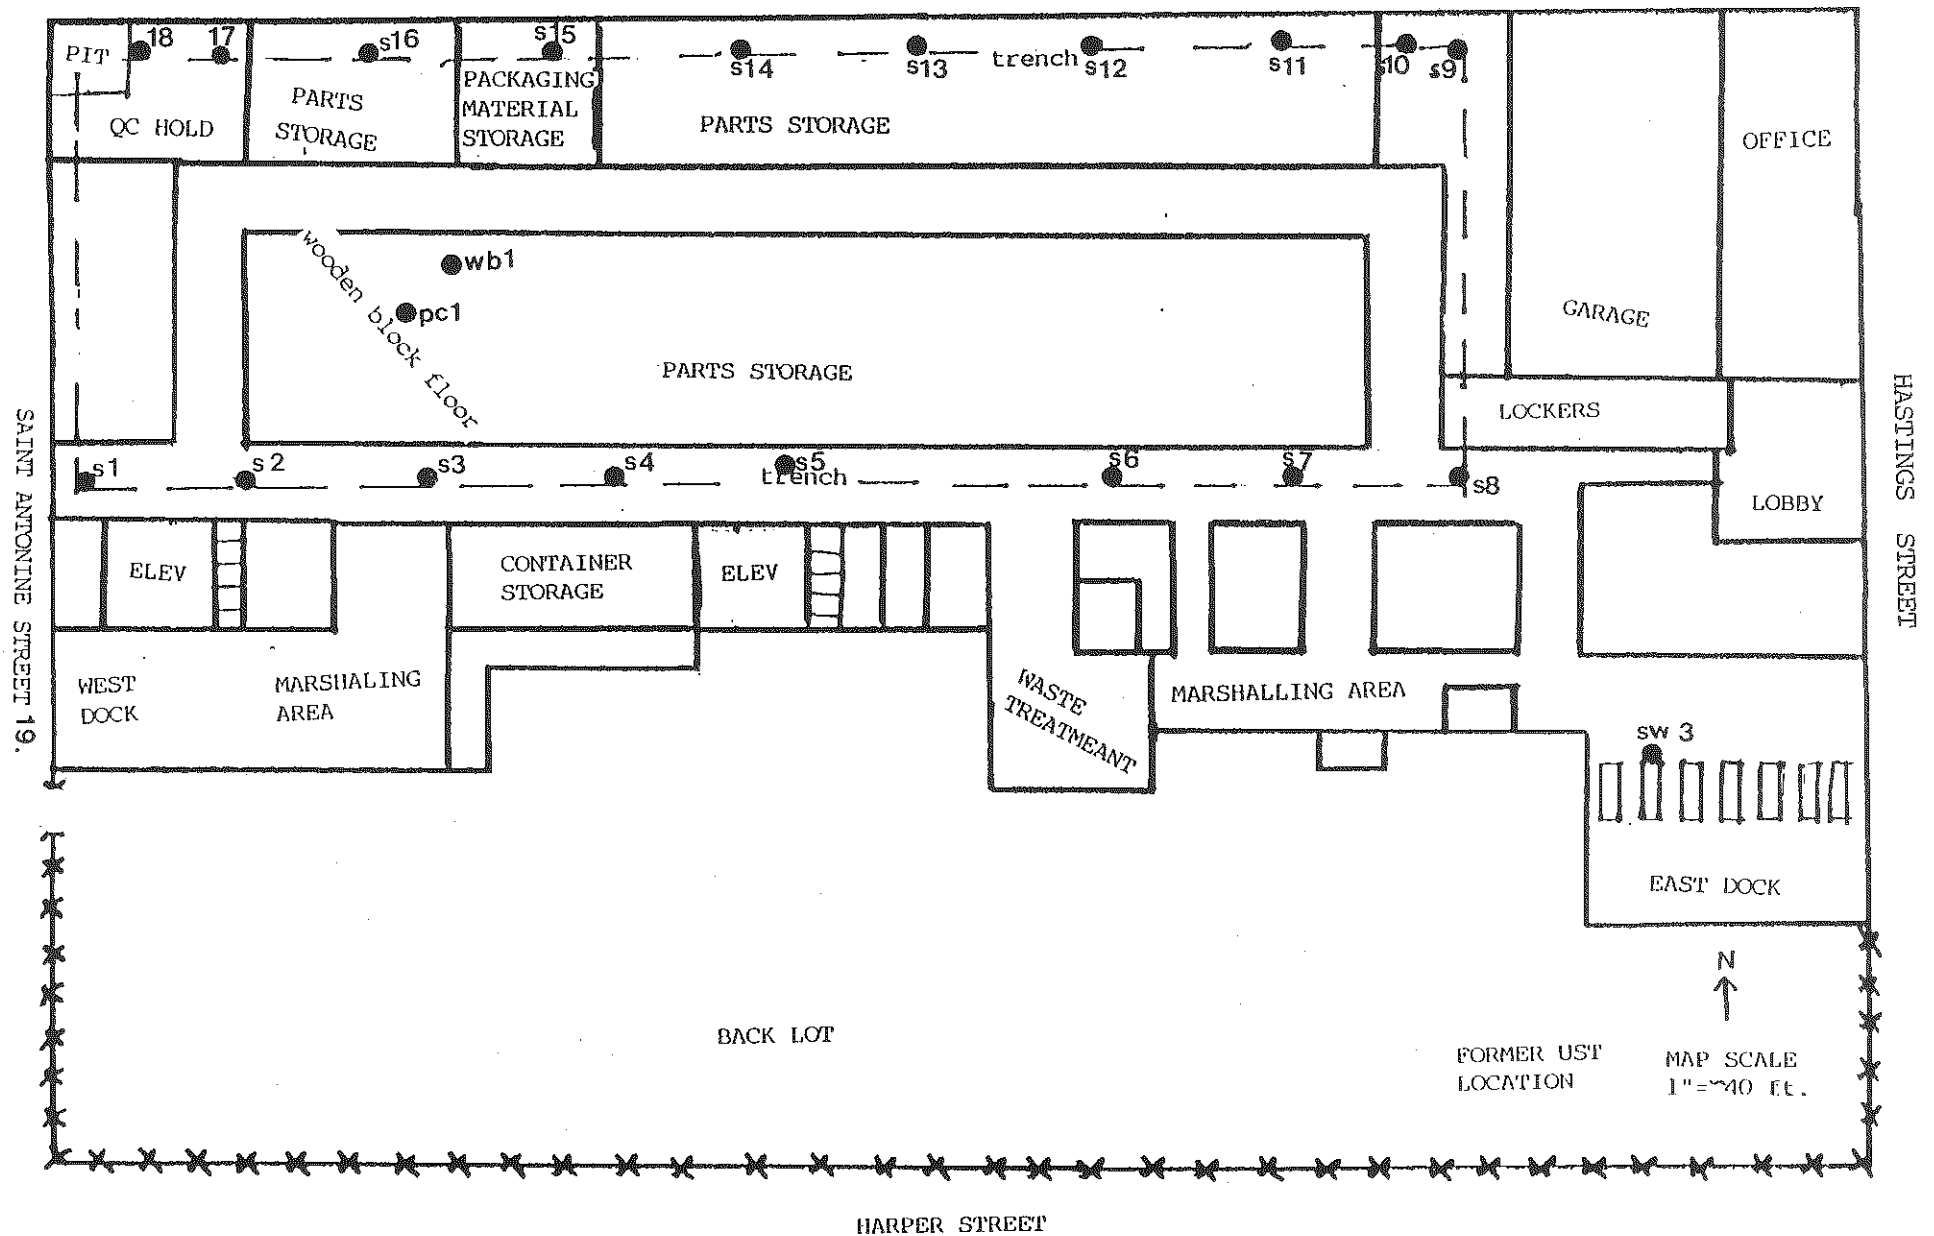
FIGURE 3

Contaminants were found in all the surficial soil samples except SS14 at concentrations which exceeded both the Generic Residential and Industrial Cleanup Criteria for Direct Contact values. These contaminants included the following: benzo(a)pyrene, benzo(a)anthracene, dibenz(a,h)anthracene, Aroclor 1254 (PCB), arsenic and lead. Only Aroclor 1254 (PCB), arsenic and lead were in concentrations which exceeded the Generic Industrial Cleanup Criteria.

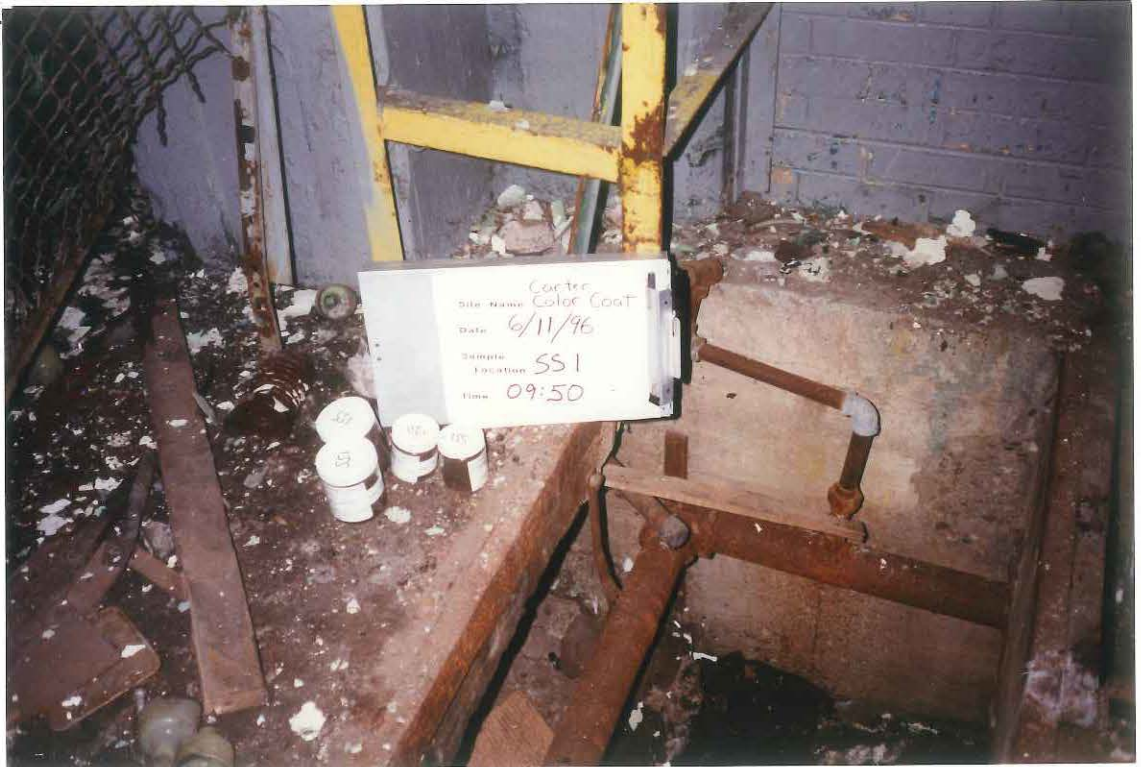
SAMPLE ID:
SS 1

DESCRIPTION:
SS1 COLLECTED FROM TRENCH IN THE GROUND FLOOR, SOUTHWEST CORNER OF BUILDING, 2 FEET FROM WEST WALL. SURFICIAL SOIL SAMPLE.

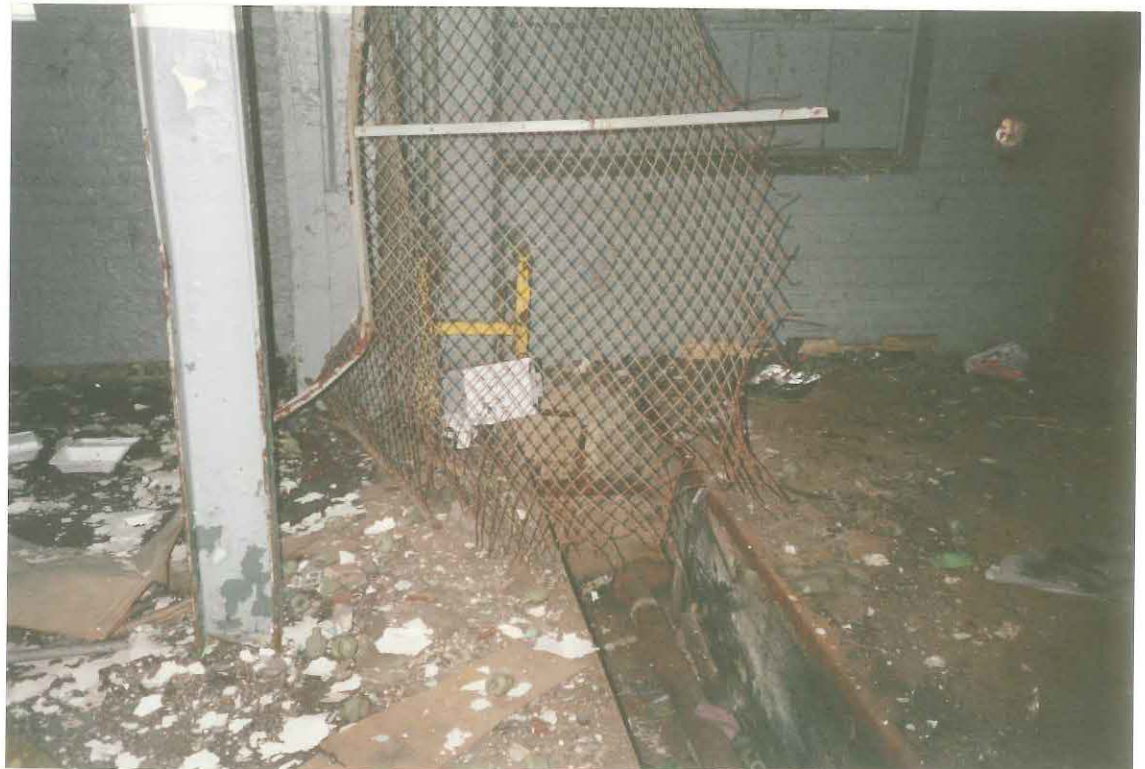
SAMPLE ID:
SS1

DESCRIPTION:
Long view of sample location.

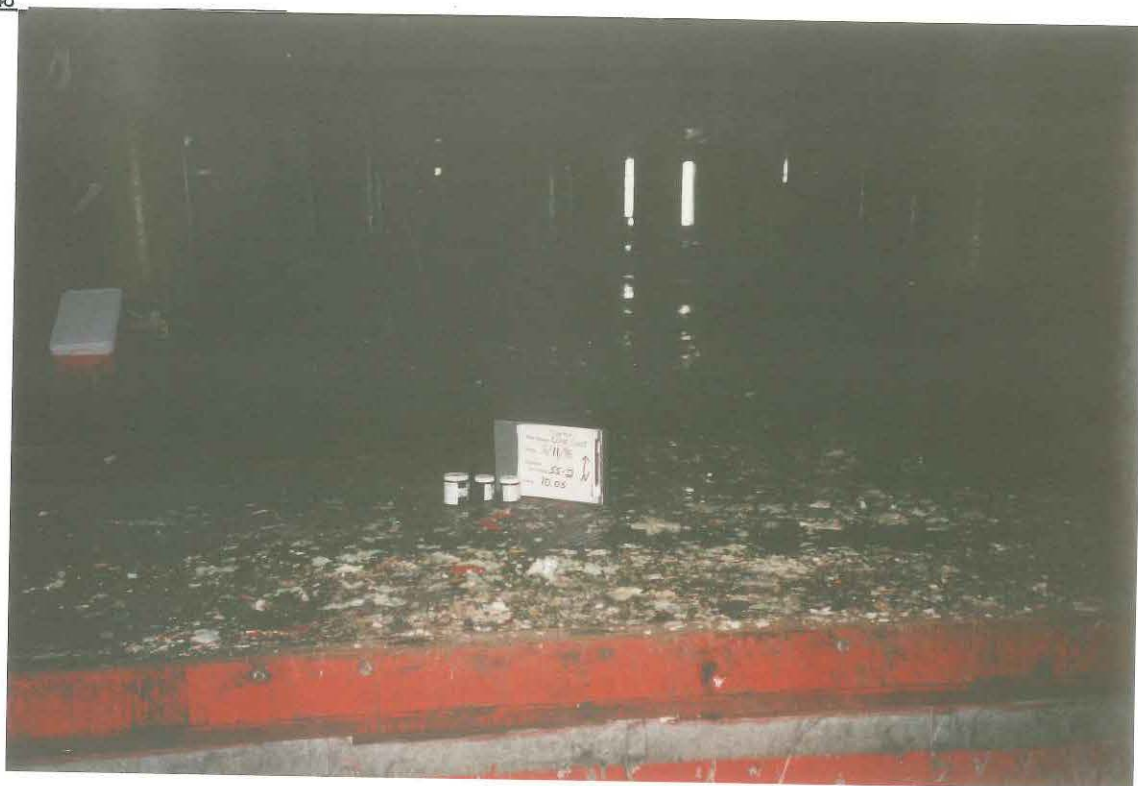
SAMPLE ID:
SS 2

SS 2 COLLECTED FROM TRENCH IN GROUND FLOOR, THIRTY FEET EAST OF SS 1 LOCATION. SURFICIAL SOIL SAMPLE.

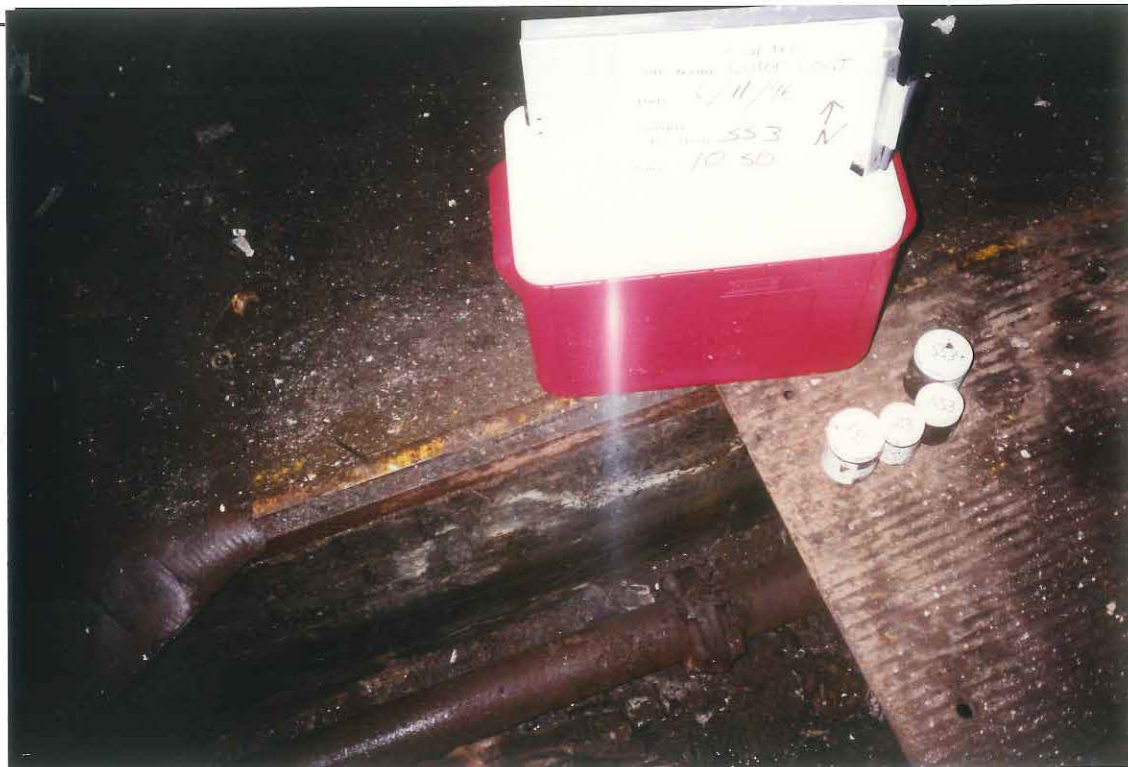
SAMPLE ID:
SS 3

DESCRIPTION:
SS 3 COLLECTED FROM TRENCH ON GROUND FLOOR, TWENTY ONE FEET EAST OF SS 2 LOCATION.
SURFICIAL SOIL SAMPLE.

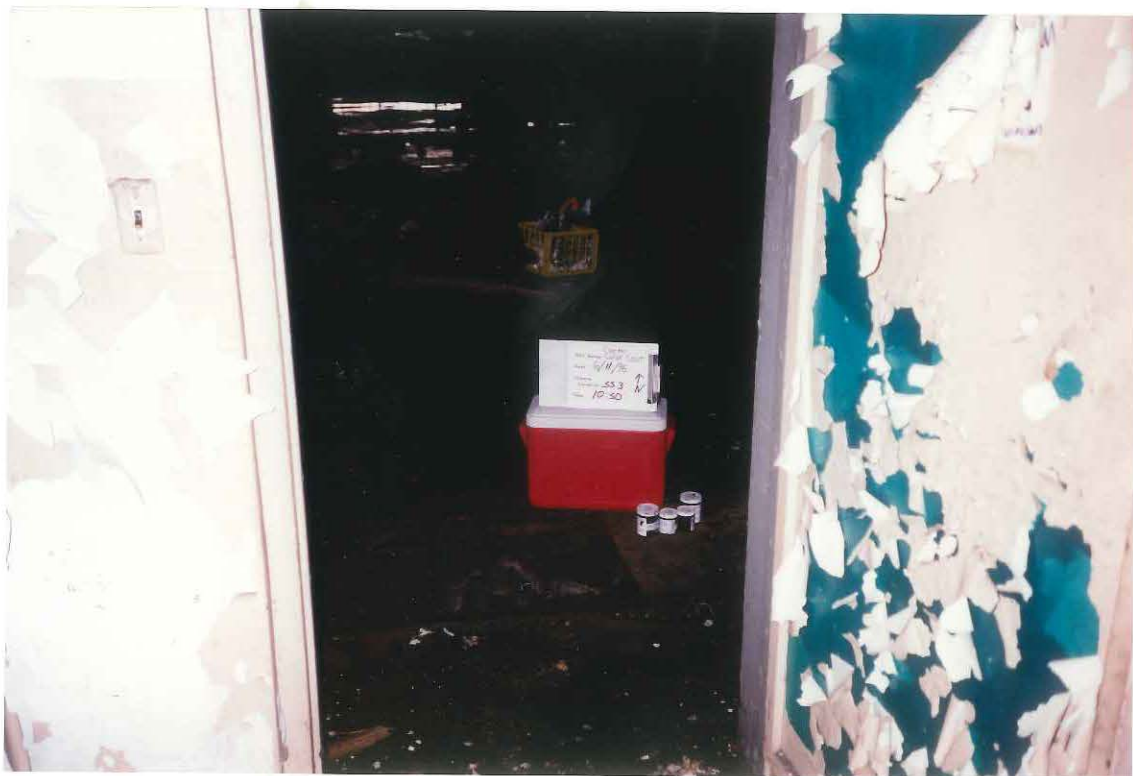
SAMPLE ID:
SS 3

DESCRIPTION:
Long view of sample location.

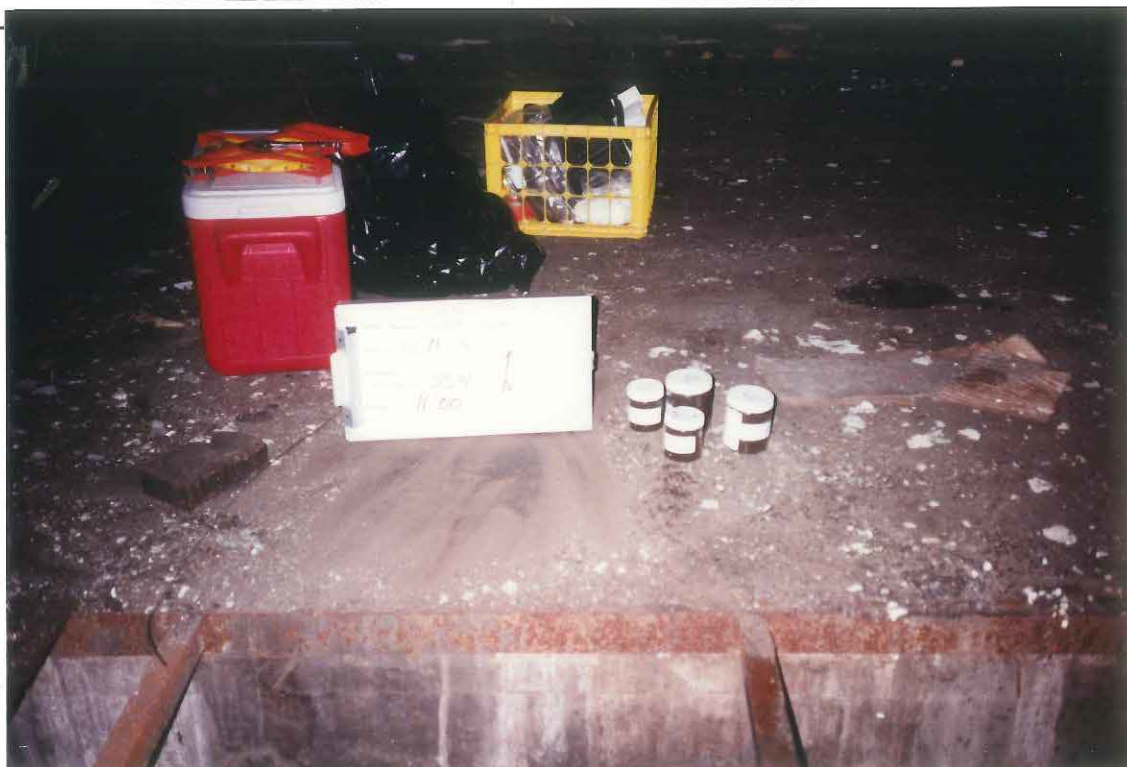
SAMPLE ID:
SS 4

DESCRIPTION:
SS 4 COLLECTED FROM THE TRENCH IN THE GROUND FLOOR, NINETY TWO FEET EAST OF SS 3 LOCATION.
SURFICIAL SOIL SAMPLE.

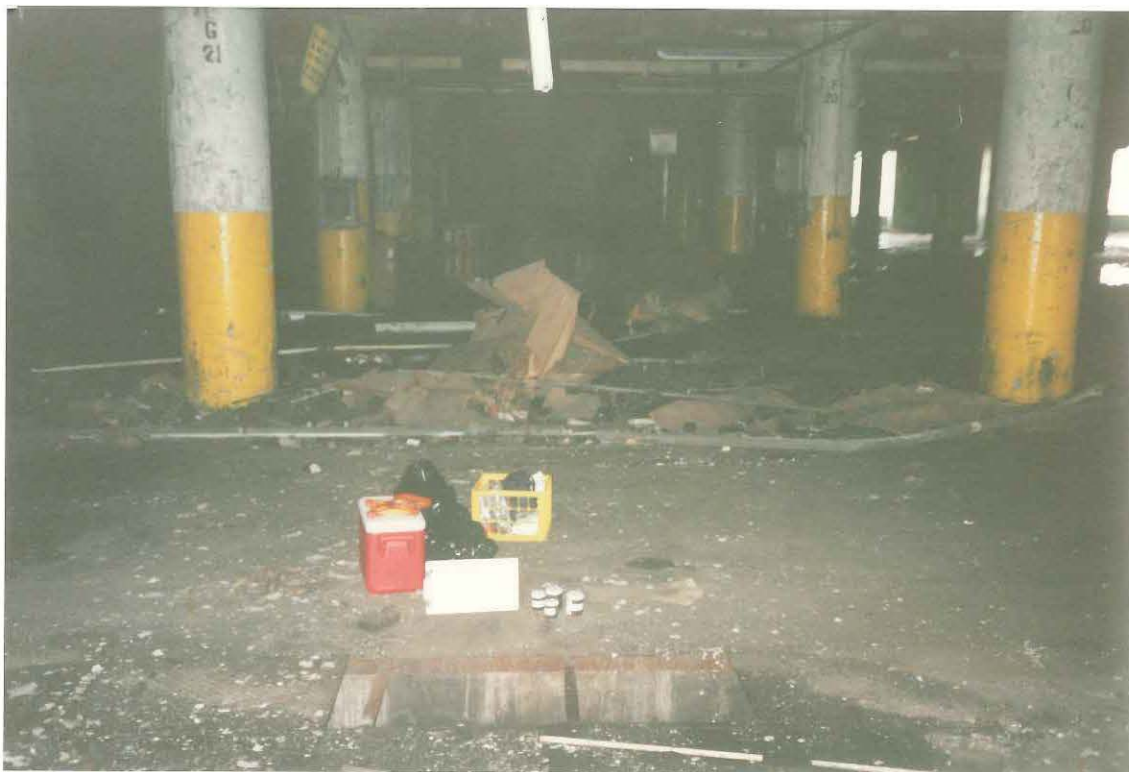
SAMPLE ID:
SS 4

DESCRIPTION:
Long view of sample location.
